THE WAR MEMORIAL OF CONSTANTINE FACING RISKS AND VULNERABILITY.

**O BOUAMEUR
N CHABI**

Department of Architecture,
University of Constantine 3
Salah Boubenider, Algeria.

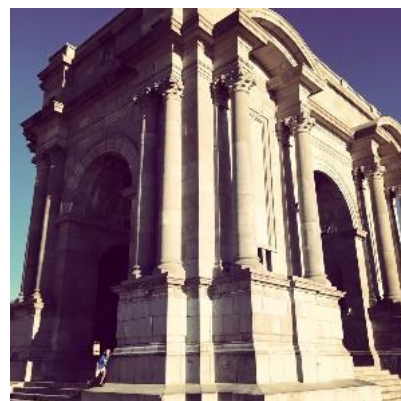
Fig. 3. *Architectural composition of the monument (Kherouatou, 2015)*

The monument remains a piece of art. As an arch of triumph, it is characterized by a colossal architectural style, particularly inspired by the arch of "Trajan" situated in the city of Timgad. It is also recognized by the rich architectonic elements of the Roman architecture such as column, bay, capital ... etc.). Besides, it is marked by a set of impressive decorative elements especially the statue of victory and the orientation table. In addition, the choice of noble materials is refined for its edification like carved stone, bronze ... etc. (Fig.3).

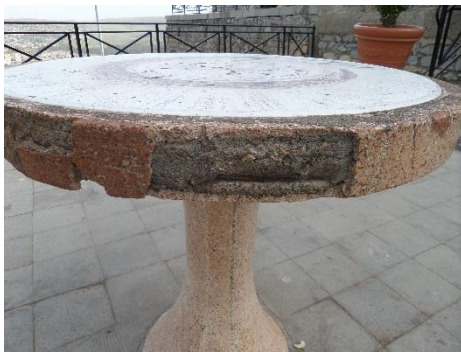
and the bronze plates were vandalized using sharp tools. Furthermore, the lock that closed the stairwell was broken off to reach the ridge. Even the orientation table in the posterior esplanade has been seriously damaged: its support suffers from instability due to an attempt to pull it out, and the map has been disfigured with white weapons (fig.10). The impact of such actions is considerable; they jeopardize its authentic original appearance, and accelerate its natural deterioration.

Fig. 10. Vandalism on the orientation table (2017).

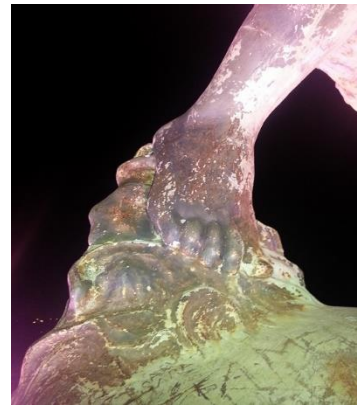
The war memorial is exposed to several adverse effects due to climatic factors. First, heavy precipitation, especially during the winter, blocks the only mechanical access leading to the monument with a large area of stagnant water. This phenomenon made the access to the monument impossible, particularly for tourists. In addition, this precipitation aggravated the problem of landslides by activating the movement of land. Moreover, the climatic effect has accelerated the corrosion of the bronze of the interior plates, as well as the statue of victory (fig.11). Due to its chemical composition containing more than 54% copper, it oxidizes with atmospheric air under the effect of moisture and carbon dioxide, creating a layer of a color called "patina" Or "grey screen". The consequences of this chemical reaction on the state of the metal are important: "A bronze statue of 70 years has lost on average 10 to 20% of its metal" [7]. This is the case of the monument, which dates back more than 85 years.

Fig. 11. The corrosion of the statue of victory (2013).

of copper arouses a lot of debate. This kind of operations was repeated for the interior walls of the monument after the installation of a faience cladding, above the authentic stone. In addition, the painting of the statue of victory to hide the effect of corrosion, which completely changed the original color. Such actions seem futile and harmless, but in reality, they seriously jeopardize the monument's heritage values, in particular its integrity and authenticity. These two fundamental elements constitute its importance and at the same time entail its safeguarding.

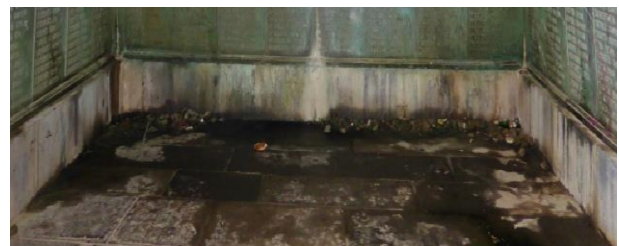
According to the survey, there are two types of pollution in the monument's site, which are visual and olfactory. Starting with the olfactory pollution; because of the absence of regular maintenance and cleaning for the different parts of the monument, especially the interior spaces, it has turned into "public urinal". In addition to the staircase and the interior walls, "the four niches under the arch and the walls covered with obituary registers of bronze, have become urinals» [8]. The interior spaces of the monument are filled with unbearable dirt and ammonia odors (fig.12). Concerning the outside environment, the visual pollution refers to the garbage bins, which are never collected regularly by the rippers. The associations or the citizens mostly handle this mission. Furthermore, the presence of a precarious habitat approximately to the monument, built of makeshift materials created a remarkable mess at the site. All these forms of pollution undermined the particular urban view of the monument, and affected negatively its reputation.

Fig. 12. Dirt in the inner niche (2013).

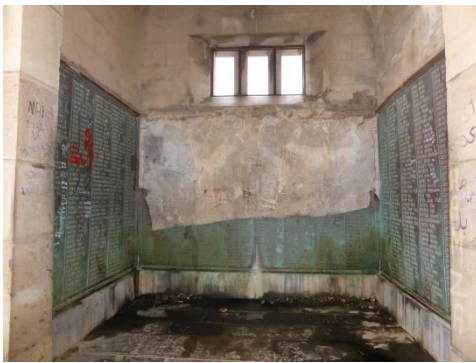
On January 23, 2014, the Commemorative plaques of bronze were severely massacred by some persons who seized the opportunity of the Algeria-Tunisia match during the African Cup to execute their crime. Using a chainsaw, two of the eight commemorative bronze plaques were torn off. A Street light powered the electric saw used in this act. Therefore, this highly historic site has been disfigured, becoming unrecognizable. The plates are unrecoverable after passing them into a foundry of copper traffic. The former mayor of Constantine stated: "We are consulting with the heritage commission of the municipality in order to call on experts and historians to provide us with the exact names of all soldiers who appeared on the missing plate. Even so, it is a hard job, but we are going to do it." [9] This irreversible loss is very serious, because it has affected the most important part of the monument. The bronze plaques represent the main reason for the edification of this monument. Certainly, a restoration will allow the recovery of the missed plate, but only in its physical aspect. The authenticity and the originality are lost forever. In fact, this kind of risks is due to the abandonment, bad attendance, and particularly the absence of security at the site. The night watchman of the monument is retired, but the municipality has not assigned a replacement to protect this war memorial. (Fig.13).

Fig. 13. *Stolen Central Bronze Plate (2013).*
